# SAFETY ALERT

LV Cable strike

Issued: 19/10/2018

| Number: 10-18

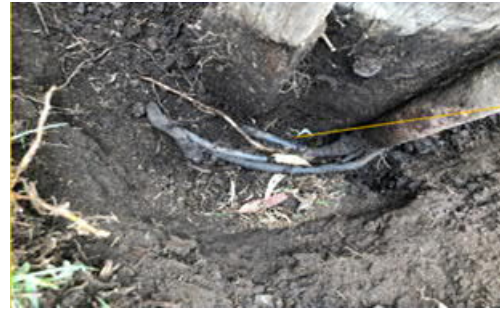
The LV electrical service was direct buried at a shallow depth of 150mm from ground level, and wrapped around the base of the pole for the purpose of a road crossing.

On investigation, it was identified that the service line was defective, and failed to meet the installation standards (SIR NSW).

Fig. 1 – Direct buried LV cable damage (at 150mm depth)

- Be aware of the potential to encounter UGOH installations that do not meet the Service Installation Rules, or asset owner installation standards.
- Undertake a visual inspection of the worksite, to identify existing UGOH installations on the pole. Identify the most appropriate methods for excavation.
- Ensure all tools used to excavate and penetrate ground are non-conductive and suitable for the task.
- Once a service is positively identified, ensure a clearance is maintained to prevent inadvertent contact.
- Document the controls within the daily pre-start risk assessment (WHRA) and ensure all persons on the worksite are familiar with the controls.

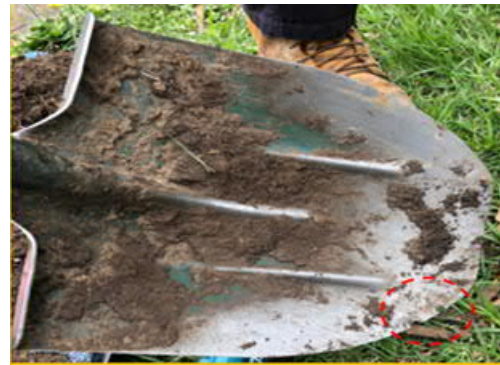
Whilst excavating around the opposite side of the pole with the intention of digging towards the location of the identified services, there was an arc from inadvertent contact with a direct buried LV electrical service line. No injuries occurred.

Fig. 2 – Damage to wooden handled shovel

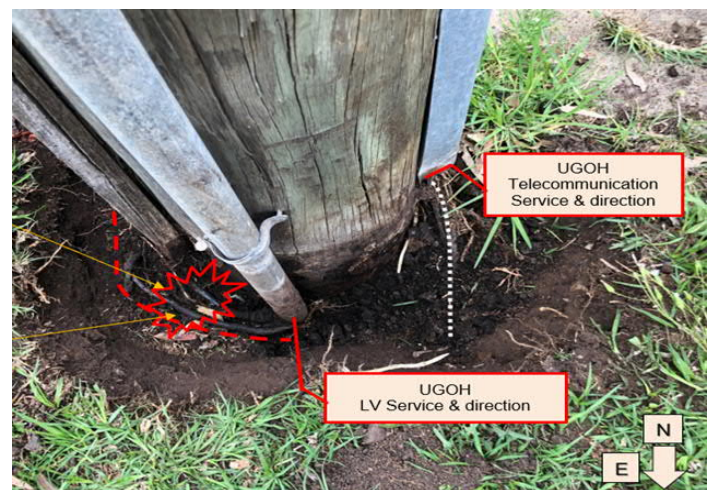
A Pole Inspector commenced excavating around the base of a network pole with a wooden handled shovel. He exercised caution during the excavation, due to the visual indicator(s) of a low voltage (LV) underground to overhead (UGOH) electrical service and a telecommunication service on the pole (Fig. 3).

Fig. 3 – Pole inspected
