# SAFETY ALERT

## Failed Ratchet Puller

Issued: 4 December 2018

| Number: 12 - 18

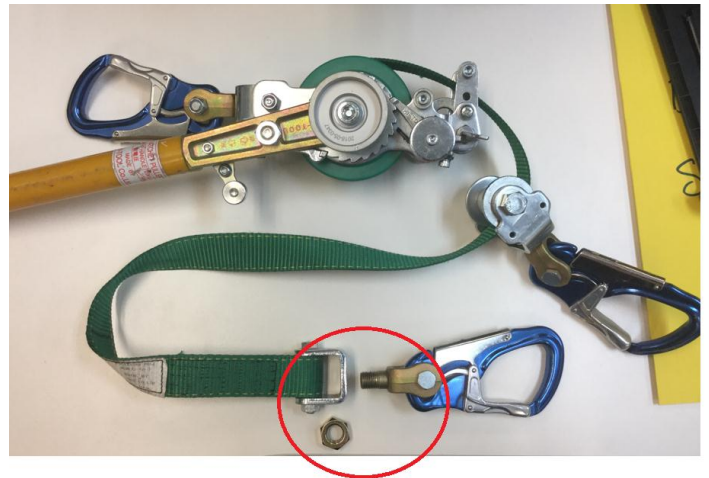
- An ICAM investigation has commenced.
- Initial findings are that the attachment split pin in the half nut connection came loose (or was not fitted adequately).
- With a defective or loose split pin, the ratchet puller (under tension and rotation) is set to fail with a resultant High Potential Incidence.
- Endeavour Energy current issued ratchet pullers have full split pins and half split pin attachments and are covered/protected within a plastic shroud.
- The Work Practices Review Committee are liaising with the supplier and Endeavour Energy CLF.

Figure 1. Red circle denotes the area of half pin dislodgement and subsequent attachment failure.

In relation to ratchet pullers the integrity of the split pins should be checked.

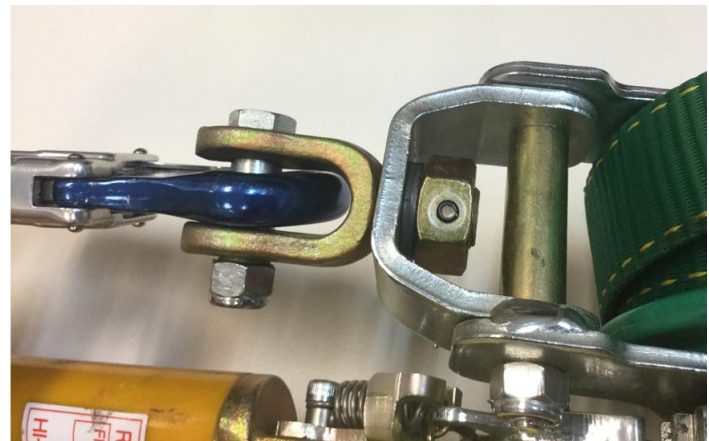
Figure 2 shows clearly the split pin attachment in the nut depicting a safe operating condition.
