SAFETY ALERT

Reverse polarity following underground service repair

Issued: 5 December 2018

| Number: 13-18

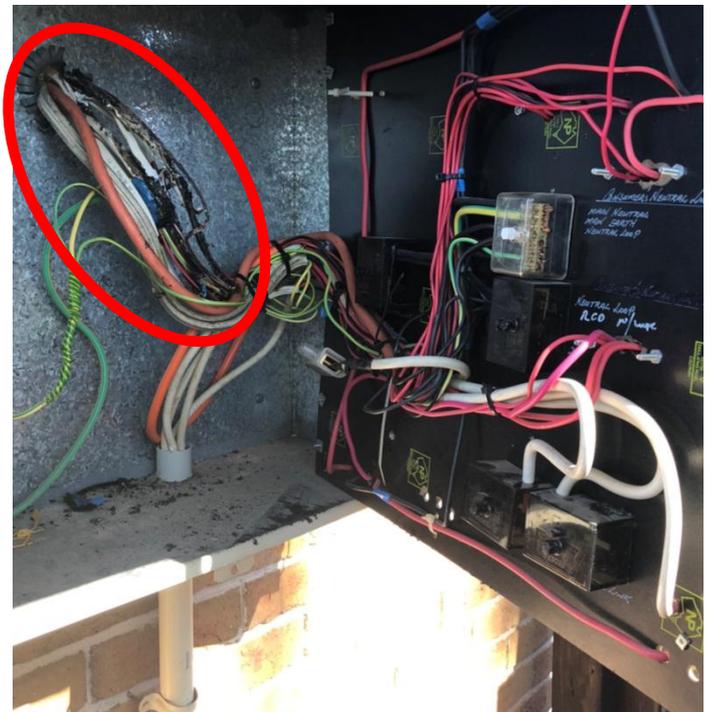
An incorrect connection was made, resulting in the service neutral being connected to an active link in the column. When a crew member went to conduct a polarity test at the customer's switchboard he noticed smoke and an arcing noise, and immediately called for his colleague to disconnect the service at the column.

The customer's installation suffered heat damage to earth conductors and bonds in the switchboard, cable duct, and roof space.

The customer's service neutral was not disconnected prior to commencing reconnection work.

Figure 1. Damage to customer's switchboard caused by the reverse polarity connection

The damage to the customer's installation was repaired by an electrical contractor the following day, and the installation safely re-energised.

All connections to the low voltage network must only be made after undertaking a documented testing process in accordance with AS4741 – Testing of connections to low voltage electricity networks. For Endeavour Energy workers this means complying with WSY0037.

Endeavour Energy employees are reminded that the company procedure requires the disconnection of the customer's neutral and phase conductors at the final connection point prior to commencing any connection work. This allows polarity and neutral integrity tests to be carried out and any connection errors identified **before** energising any part of the customer's installation. Where the final connection point is the customer's switchboard, this disconnection is achieved by removing all service fuses and disconnecting the incoming service neutral from the service neutral link.
