SAFETY BULLETIN

Fall from Height due to failed Private Steel Pole

Issued: 26 April 2018

Number: 7 - 18

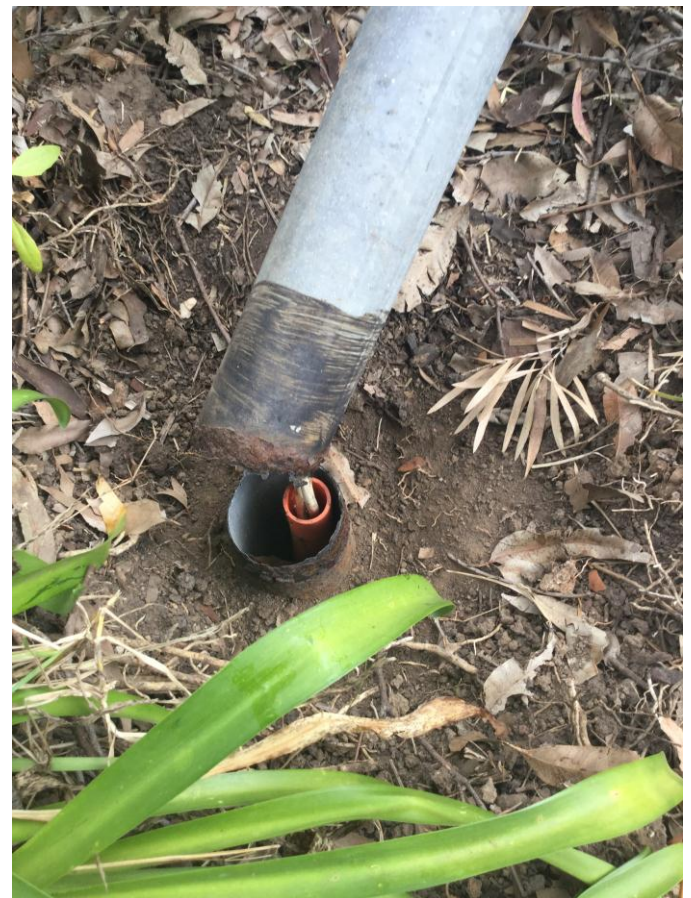
Rust was found (no flaking or holes visible at the time).

The steel pole snapped at the base, coming to rest against temporary fencing (located nearby).

Figure 1. Rusted pole base – pole failure.

Effective immediately, **No steel service pole will be climbed until review of our process has completed**, as current RA process has failed.

- Continue to utilize an Elevated Work Platform (EWP) when working on a steel private pole.
- Consider a self-supporting ladder or a temporary scaffold to access heights.
- If these devices are not available (nor practical), staff are to cut away mains and make safe, contact your supervisor who can arrange an OLI/GLI inspection if required.
- If the pole is to be referred to the OLI/GLI the Fault & Emergency Trouble Order shall be closed with the completion code "415 LV S/L Column/Pole".
- Any repairs to the service pole will be the responsibility of the customer and advised by the OLI / GLI inspection process.
