SAFETY BULLETIN

Low Voltage Switching Incident in URD Column

Issued: 13 June 2018

| Number: 13-18

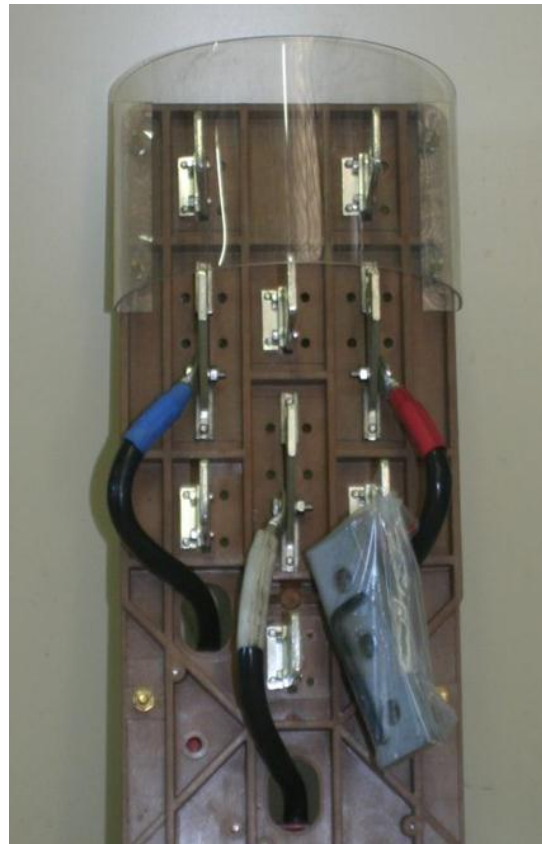
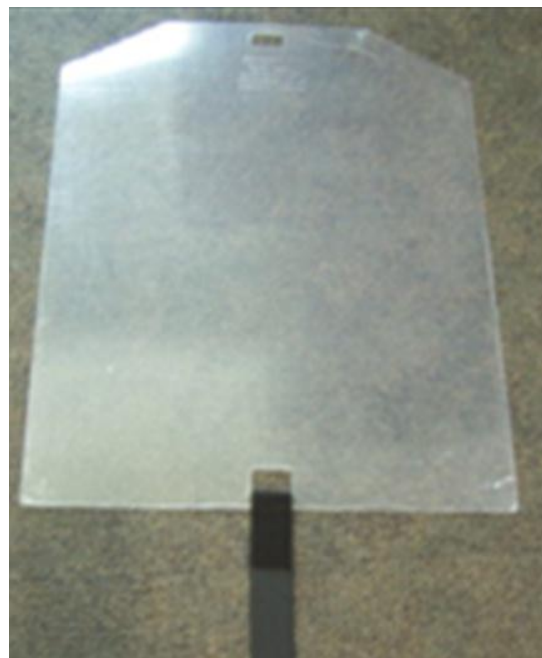
The operator started to close the normally open contact when the board partially moved/flexed as a result of the switching action and made contact with the earthed URD Column. There were no injuries but the fault caused a fire within the column.

The subsequent investigation found that the incident occurred by a crack in the polycarbonate insulating sheet at the rear of the column.

- Conduct visual inspection to confirm mechanical integrity of the LV board and associated mounting hardware.
- Be aware of the associated SWMS and its instructions.
- Be aware of the potential for this type of incident
- Carry polycarbonate sheeting (Stock Code: 001558865) and if determined to be required prior to the switching operation install this engineering control behind the LV link board whilst the switching operation undertaken (easily installed and removed)
