SAFETY BULLETIN

Potential Unsafe Ground line Condition of Telco
'Common Use / G-Poles'

Issued: 23 August 2018

| Number: 19 - 18

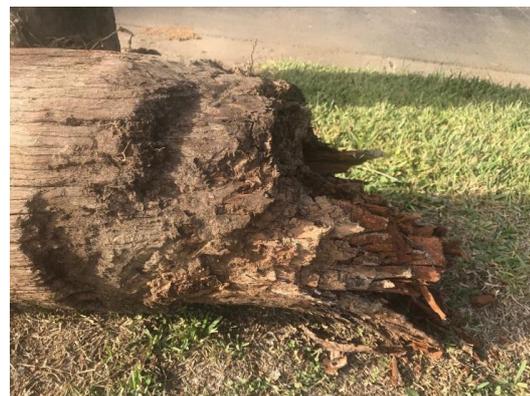
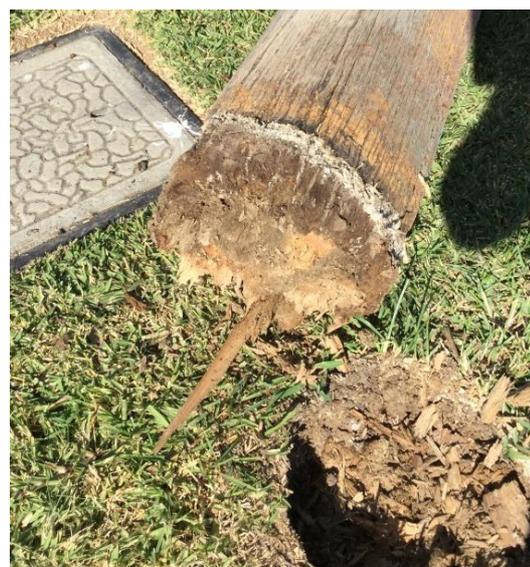
Figure 1 – Examples of ground line condition of failed poles

A number of service poles have recently failed or been found at risk of imminent failure due to extremely poor condition at ground line. These poles were recorded in our Ellipse and GIS databases as being owned by Telstra. These poles are known as 'Common Use' poles and the pole number preceded by a 'G' on GIS maps. 'Common Use/G-poles' are poles owned by a Telco that also support Endeavour Energy's overhead mains – generally a service road-crossing.

Until now the responsibility of the GLI inspection has been left to the utility owner. However, these recent incidents have highlighted a possible deficiency in the utility owner's inspection process and in the accuracy of the pole ownership data in Ellipse and GIS.

- Do not climb the pole. Do not perform a 'ladder test' on the pole.
- Use an alternative method to access the pole such as using an EWP.
- No conductors are to be cut away, or tension otherwise changed, unless the pole is appropriately supported.
- Ensure any potential drop zones in the event of a pole failure are identified and kept clear of personnel.

- If staff are concerned about the condition of a pole, or suspect its ownership is incorrectly recorded – then contact the OLI/GLI group to arrange a Special Inspection.

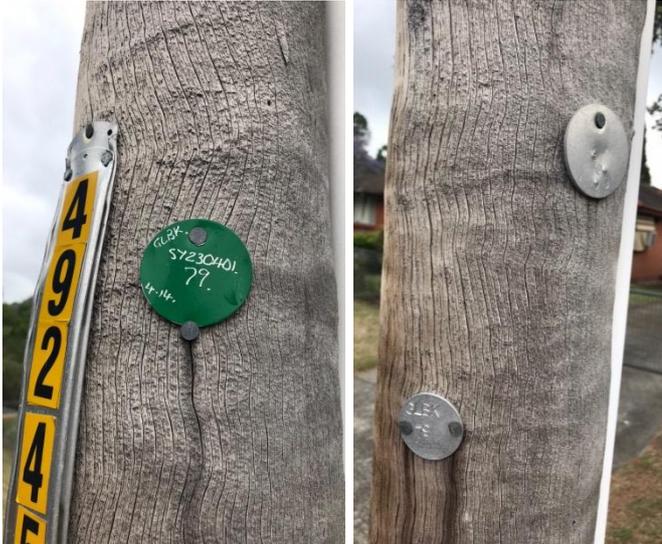
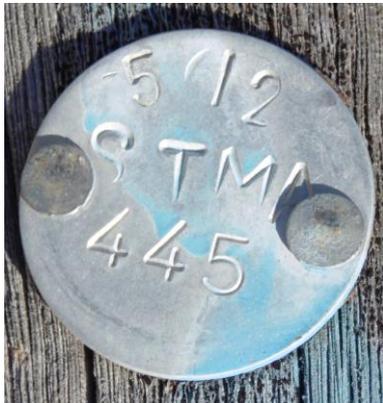
Pole Discs: Small round steel pole disc, various colours, generally appear alongside Endeavour pole number plates.

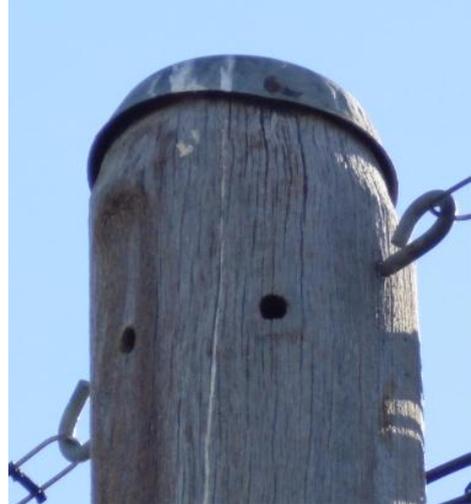
Pole Caps: 'Pie dish' shaped pole cap.

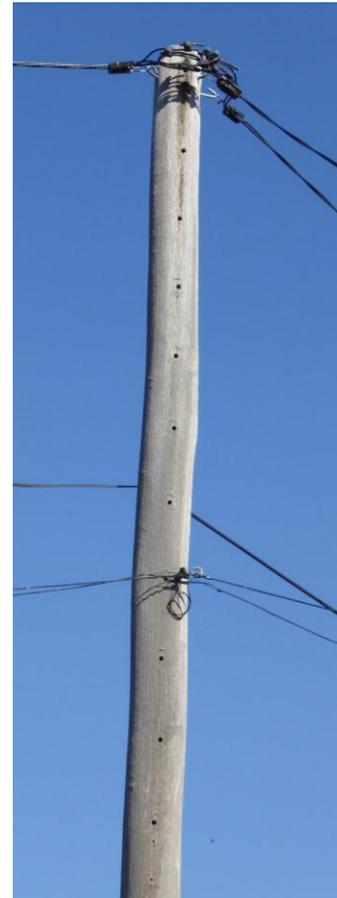
Old Insulator Holes: Multiple holes down the pole from the removal of old insulators.
